OPERATION

PLUMBBBOB

Project 3.1

BLAST LOADING AND RESPONSE OF UNDERGROUND CONCRETE-ARCH PROTECTIVE STRUCTURES (U)

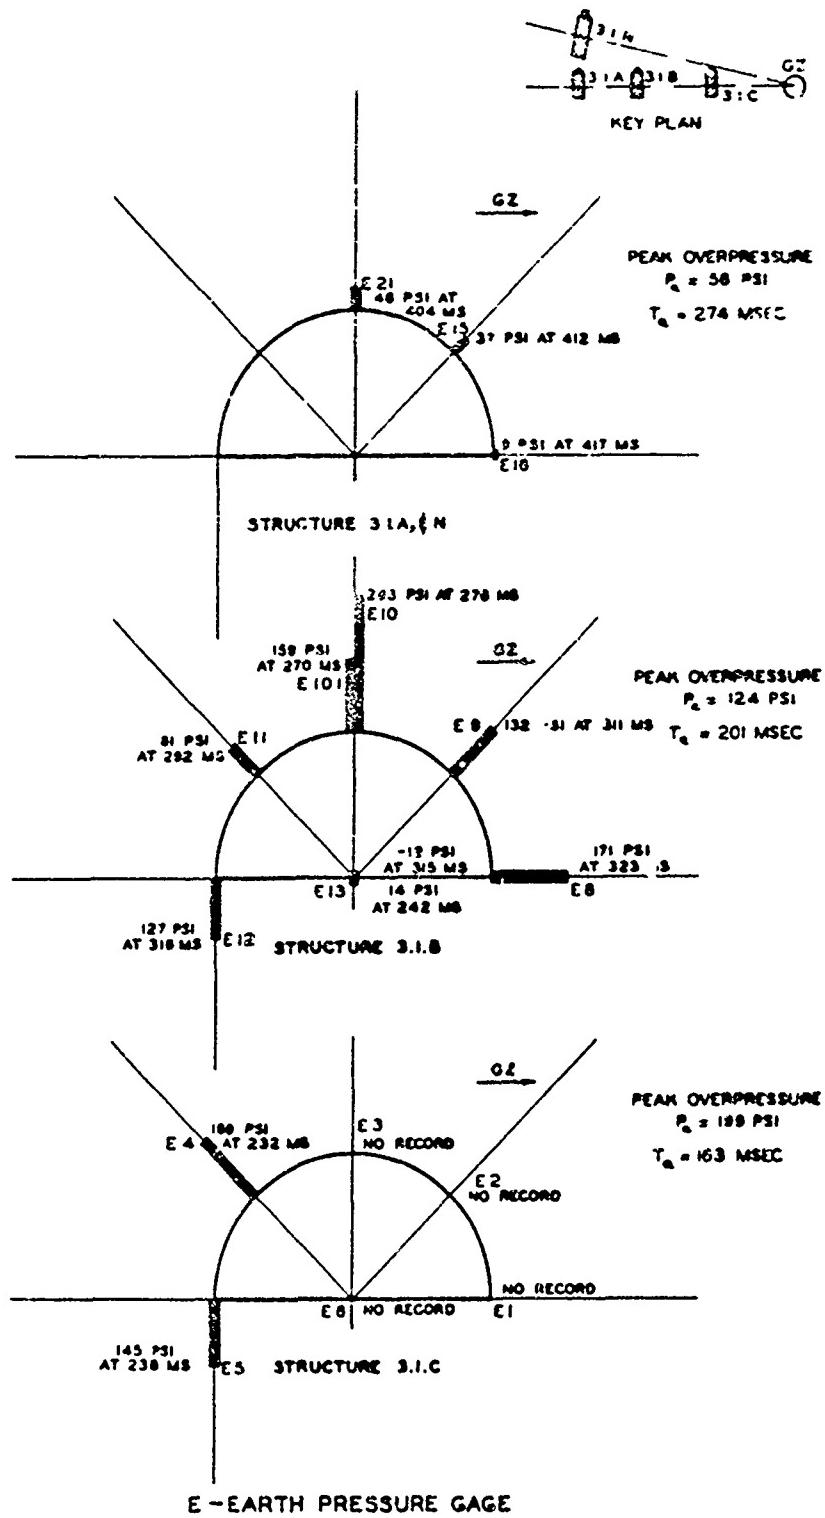
Figure 3.1 Peak transient earth pressure, Structures 3.1.a, b, c, and n.

The peak transient earth pressures on Structure 3.1.b (see Figure 3.1) show that in several instances the earth pressure exceeded the ground-surface air overpressure. Even though the values of pressure were recorded to the nearest one psi, some of the values could not be accurately determined because either the range of the calibration or the range of the amplifying equipment was exceeded. This was especially true for gages E10 and E10.1, at the crown of Structure 3.1.b. These gages were placed next to each other in order to determine what effect the method of mounting had on earth-pressure measurements (see Appendix B). Only the peak earth-pressure values for the precursor phase could be compared since the peak values for the main shock phase were beyond the calibrated range of the gages.

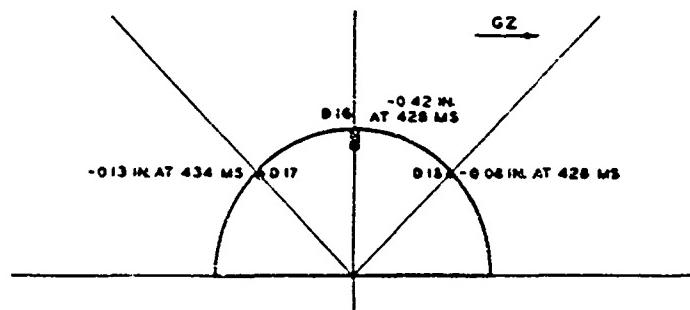
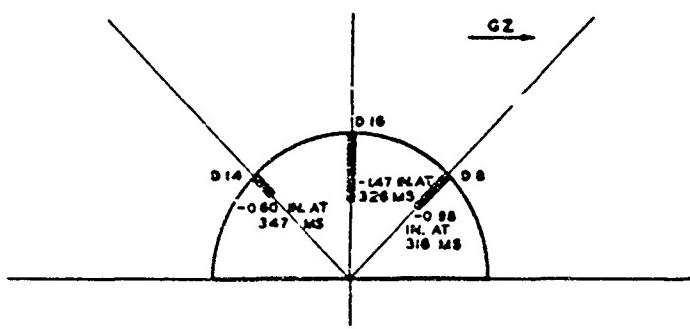
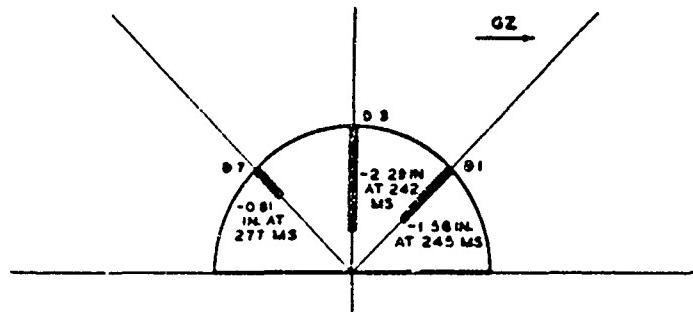
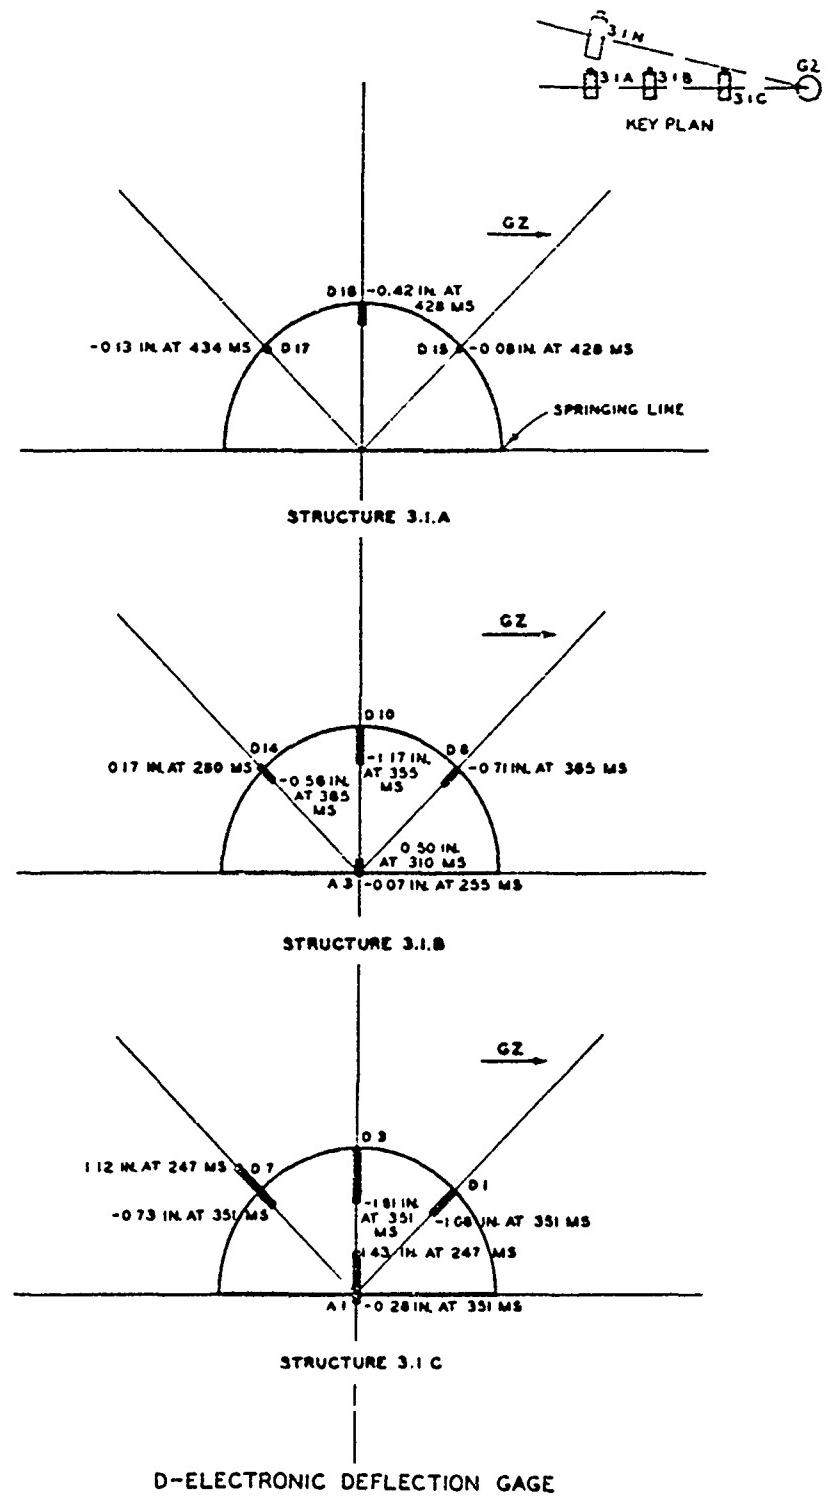
Figure 3.2 Peak transient deflection, with respect to the center of the floor slab, Structures 3.1.a, b, and c.

The peak transient radial deflections of the arch with respect to the center of the floor slab for Structures 3.1.a, b and c are shown in Figure 3.2. These values are the actual recorded maxima, as read from the deflection-gage records. However, the floor slab itself underwent differential deflection as indicated by comparing the integrated acceleration records (see Figures 3.7 and 3.8). Therefore, the plots of peak transient radial deflections of the arch were adjusted,

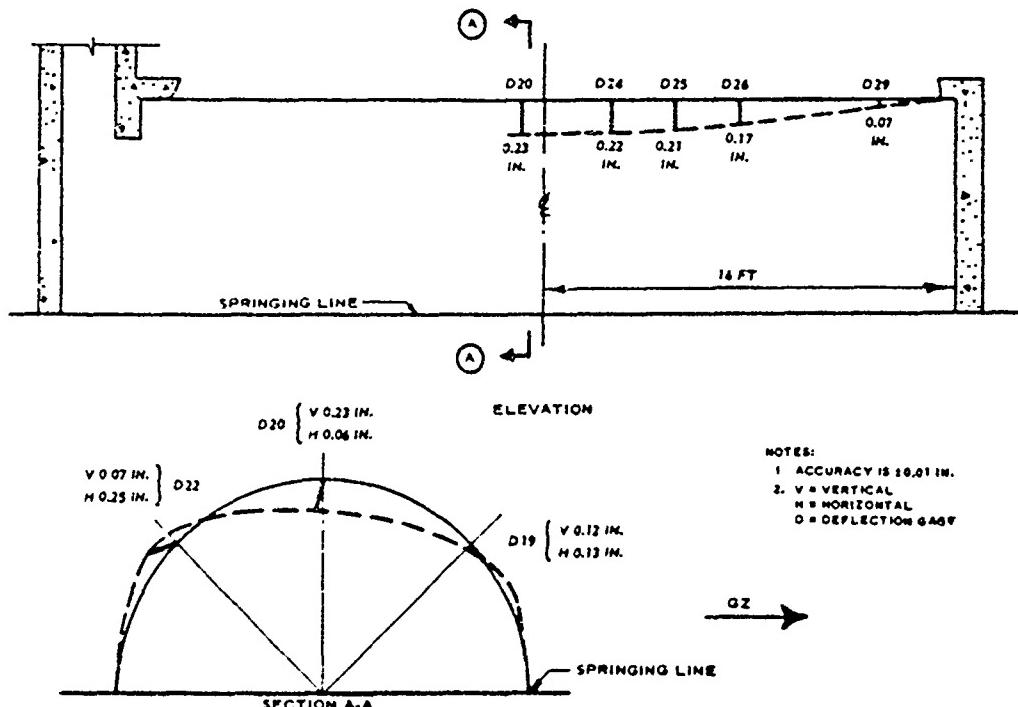
Figure 3.4 Peak transient deflections with respect to the springing line, Structure 3.1.n.

The peak transient deflections of the 3.1.n arch with respect to the springing lines are shown in Figure 3.4. In this structure two gages were used at each point to trace both the horizontal and vertical movements. Section A-A of Figure 3.4 shows the maximum excursion of three points on the intrados near the center of the structure. These deflections show that the structure underwent bending with the crown moving downward and the haunches outward. It can also be observed that the bending was slightly asymmetrical with some movement away from ground zero. The elevation view shows the deflections of the crown along the longitudinal center line of the arch. The deflections of this structure were not large enough to definitely establish the distance to which the end walls affected arch action. This was indicated, however, by the pattern of the cracks discussed in Section 3.8.

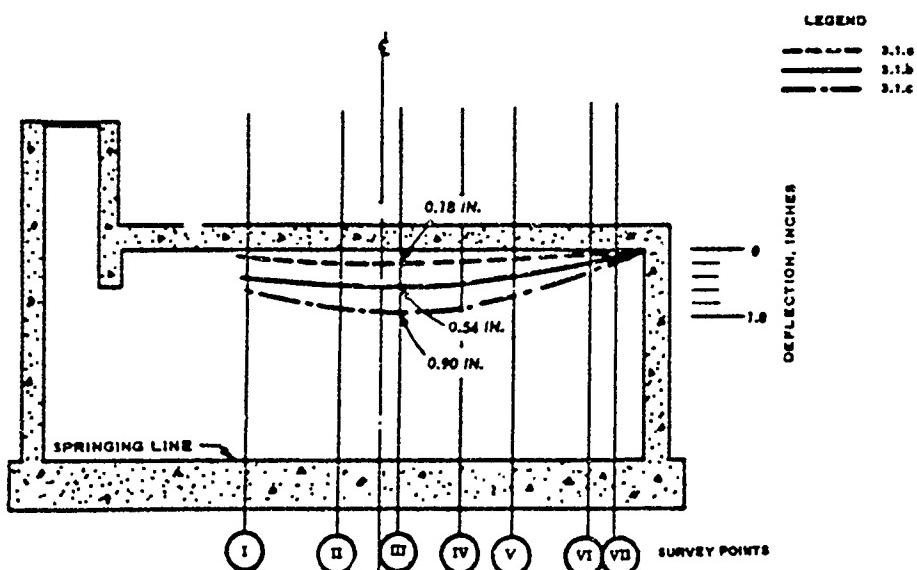
Figure 3.5 Permanent crown deflection with respect to the springing line of the arch, Structures 3.1.a, 3.1.b, and 3.1.c.

The permanent deflection of the crown with respect to the springing line for Structure 3.1.a, b, and c is compared in Figure 3.5, again showing the influence of the end walls in restraining

arch deflection. The permanent deflection of the crown with respect to the springing line for Structure 3.1.n measured less than 0.05 inch. The permanent deflections determined from a level survey are given in Tables 3.1, 3.2, 3.3, and 3.4.

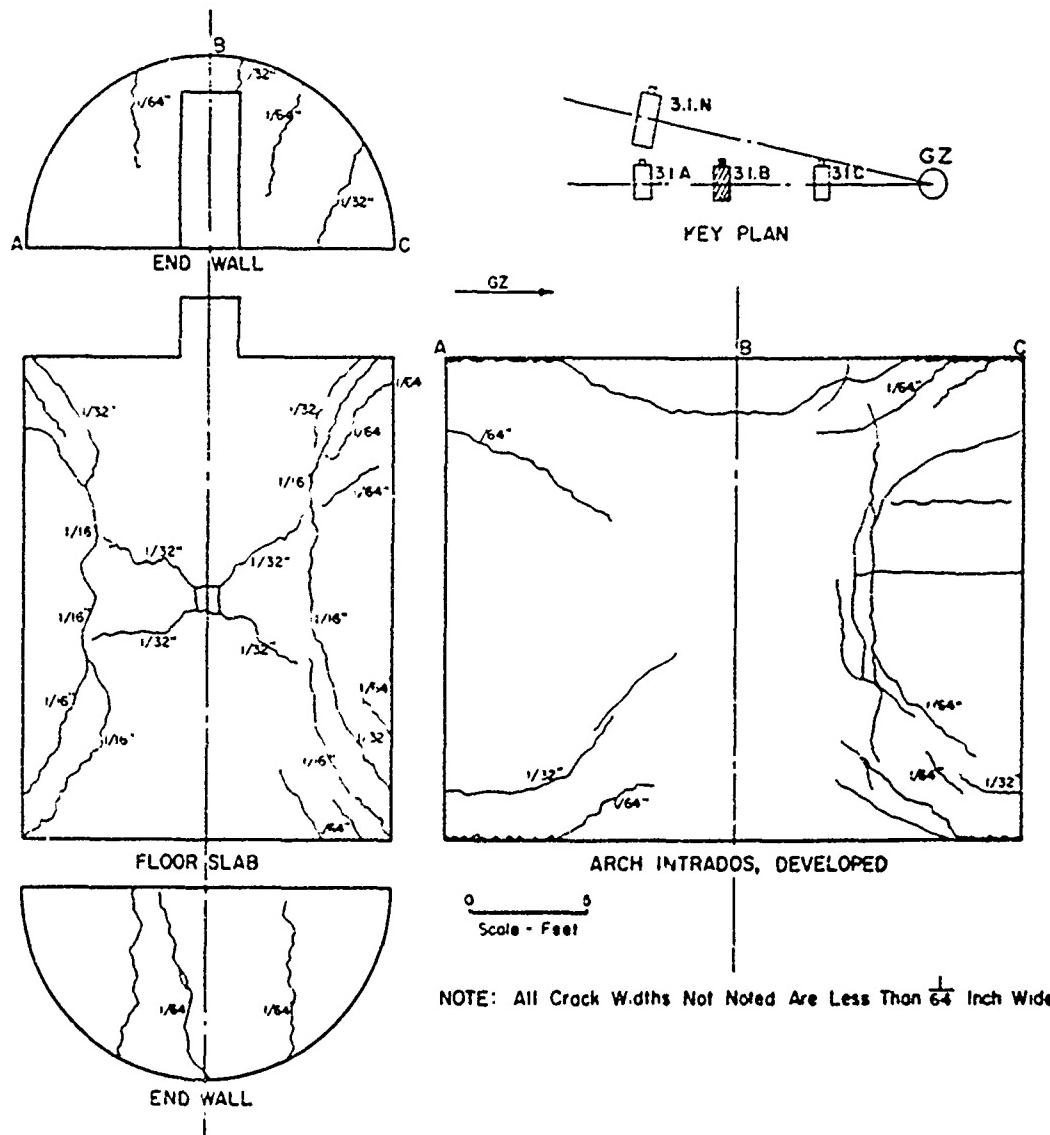
Figure 3.18 Postshot crack survey, Structure 3.1.b.

in the intrados varied from hairline to $\frac{1}{32}$ inch. It is apparent that the floor slab underwent bending, with the top of the floor slab in tension. Horizontal hairline cracks located 7 feet above the plane of the springing lines on the ground-zero side of the intrados show that the arch also underwent bending. Figure 3.18 shows the results of the postshot crack survey of this structure.

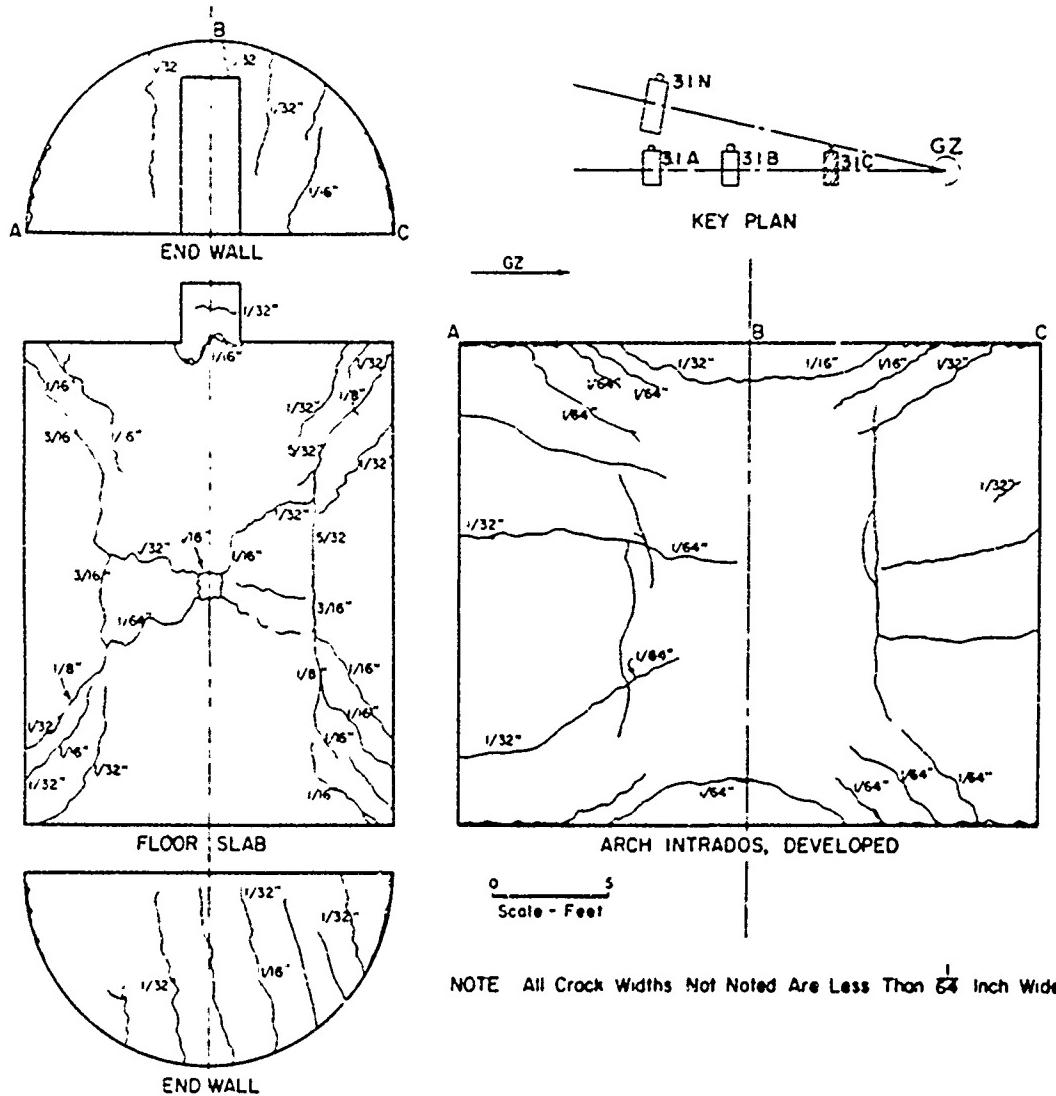
Figure 3.19 Postshot crack survey, Structure 3.1.c.

Structure 3.1.c. A large number of cracks developed in the floor slab, intrados, and end walls of this structure. The width of the cracks in the floor slab varied from hairline to $\frac{3}{16}$ inch,

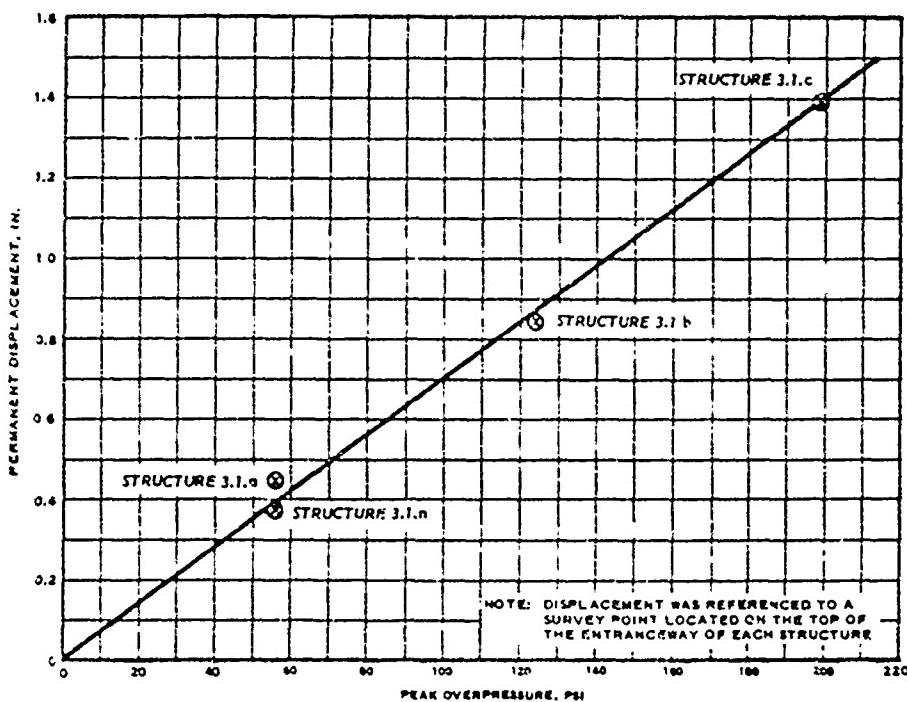
Figure 4.1 Permanent downward displacement of the 3.1 structures.

It was found that the four structures underwent a gross transient and permanent downward displacement, as well as relative deflections of the arch and floor slab with respect to the springing lines of the arches. The total permanent downward displacements of the four test structures, referenced to a survey point located on the top of the entranceway of each structure, is presented in Figure 4.1, showing that the displacement caused by the blast increased linearly with air overpressure up to the 200-psi level.

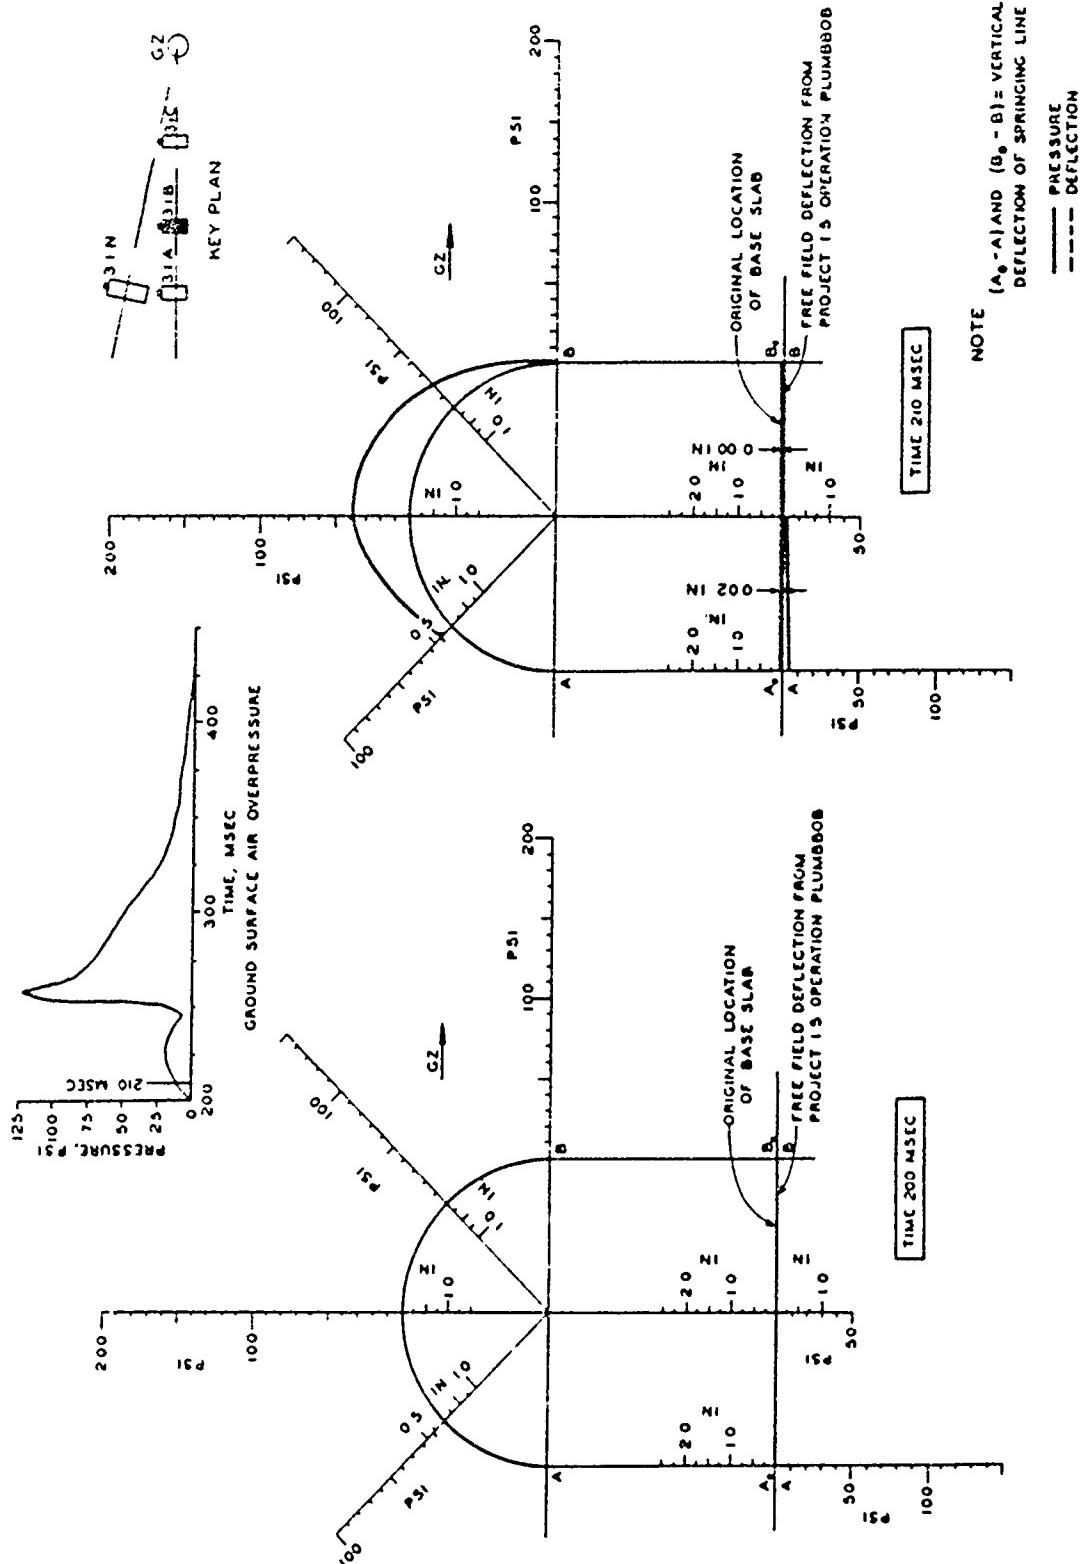
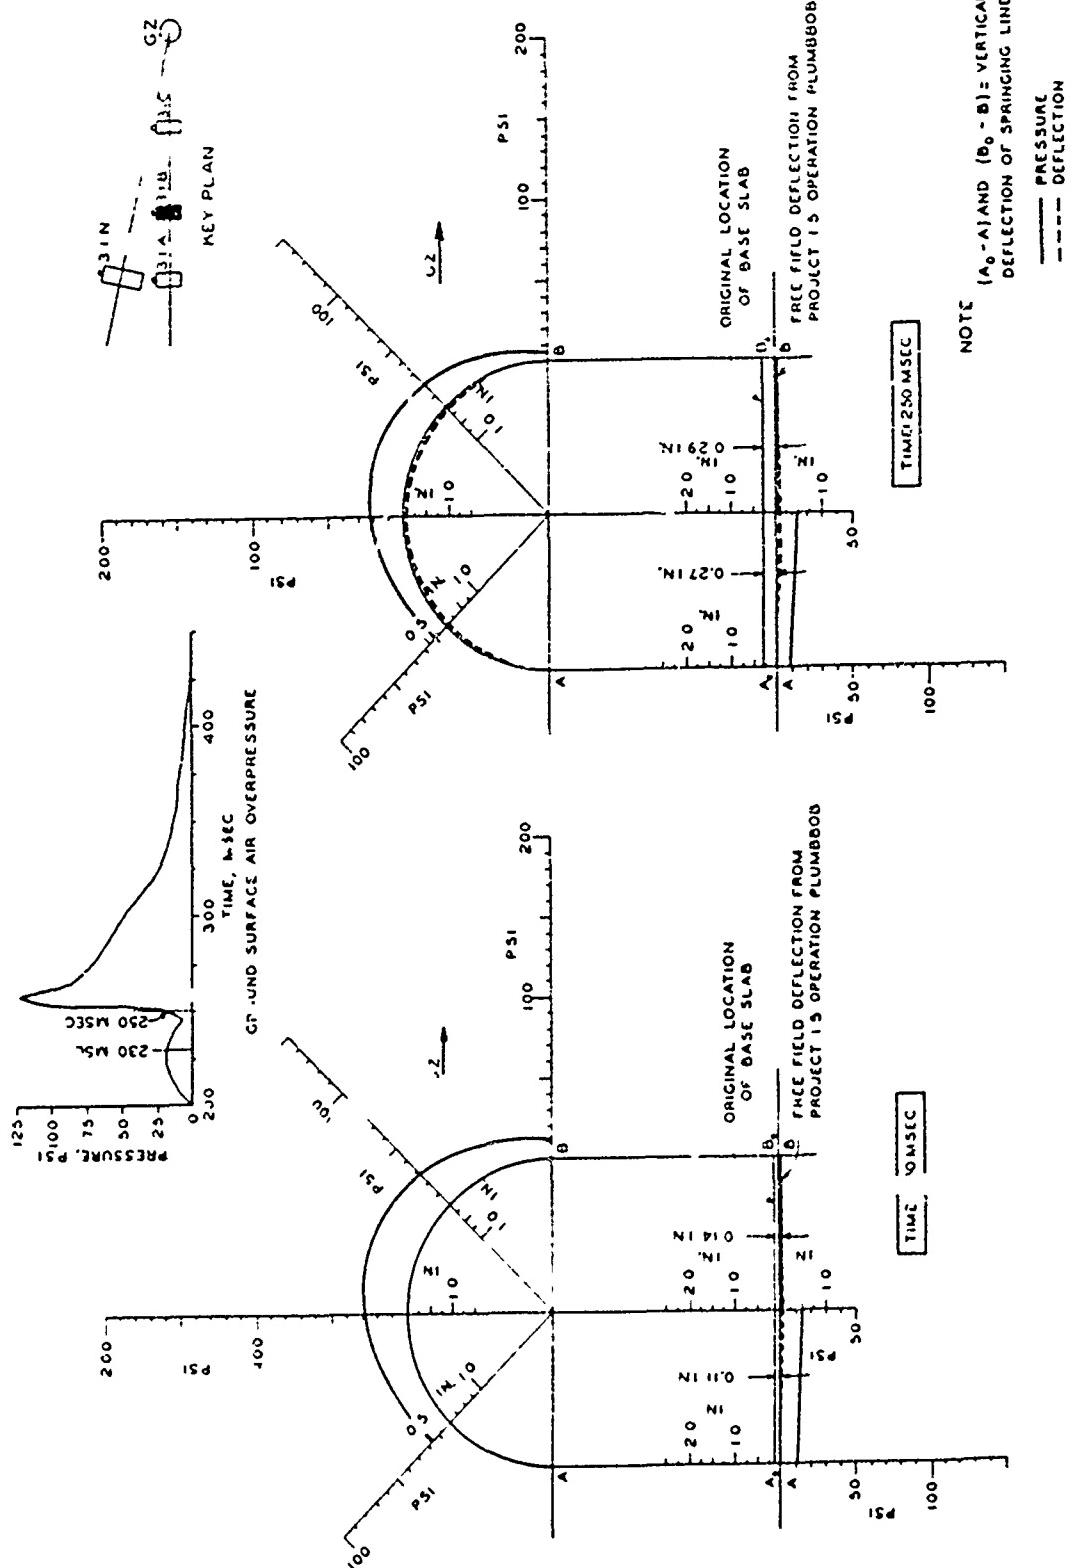
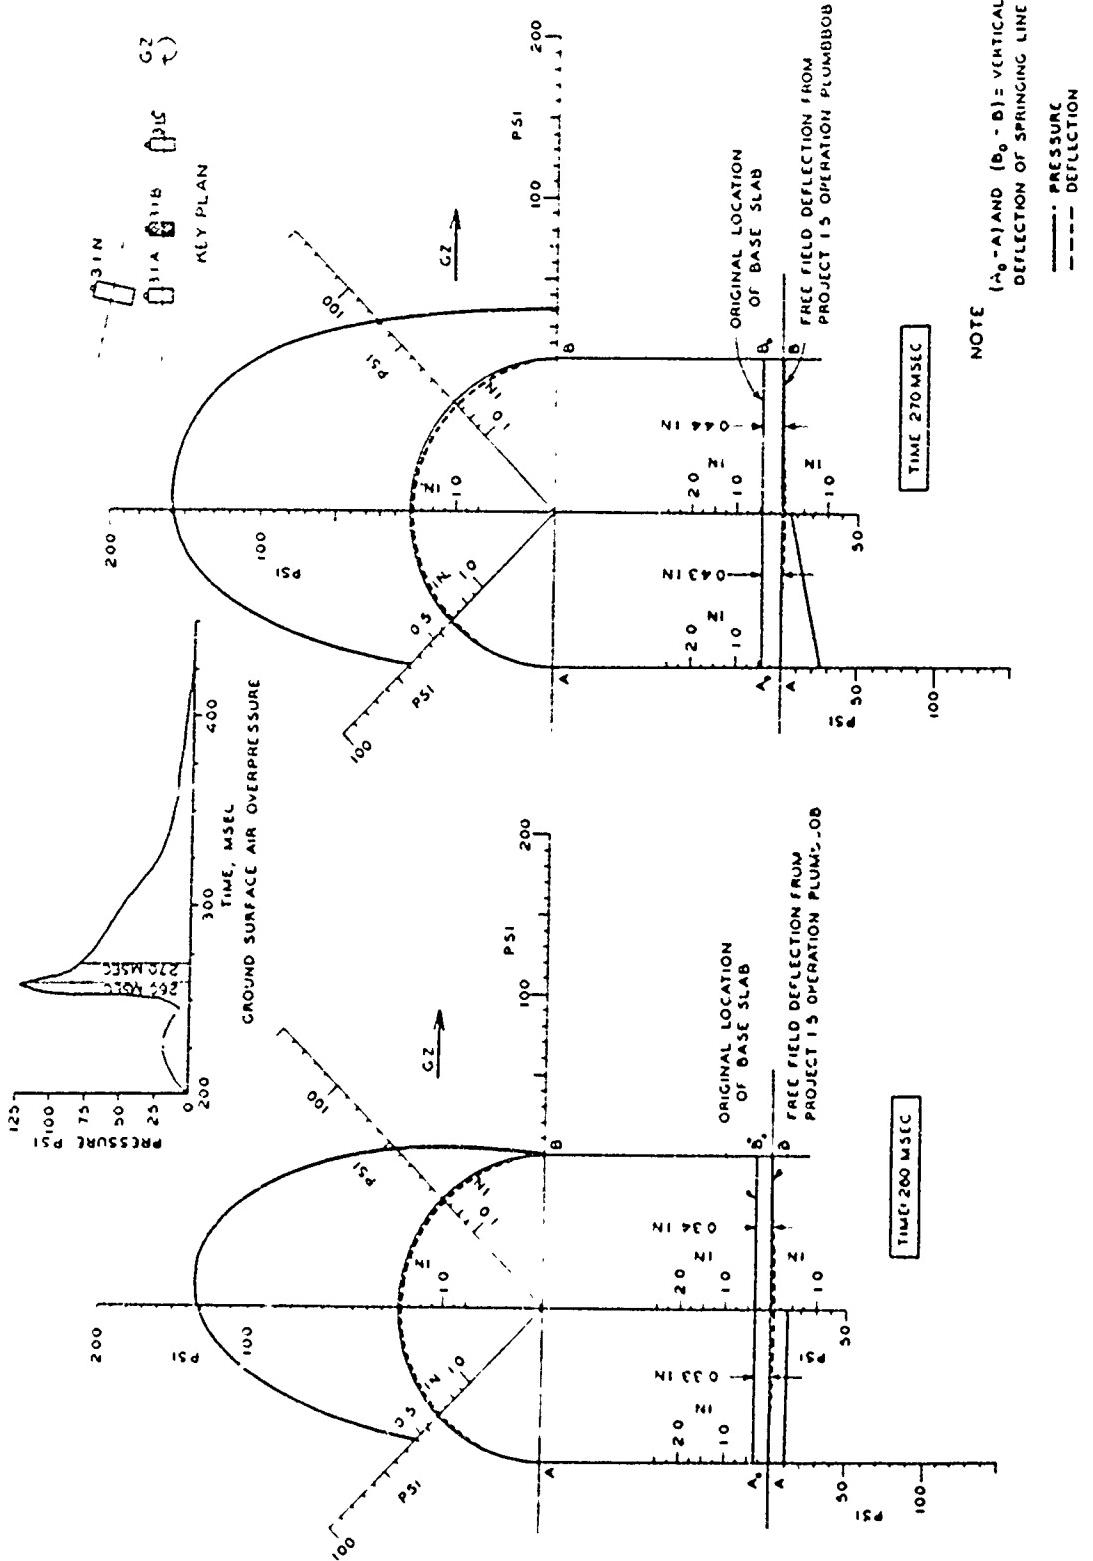
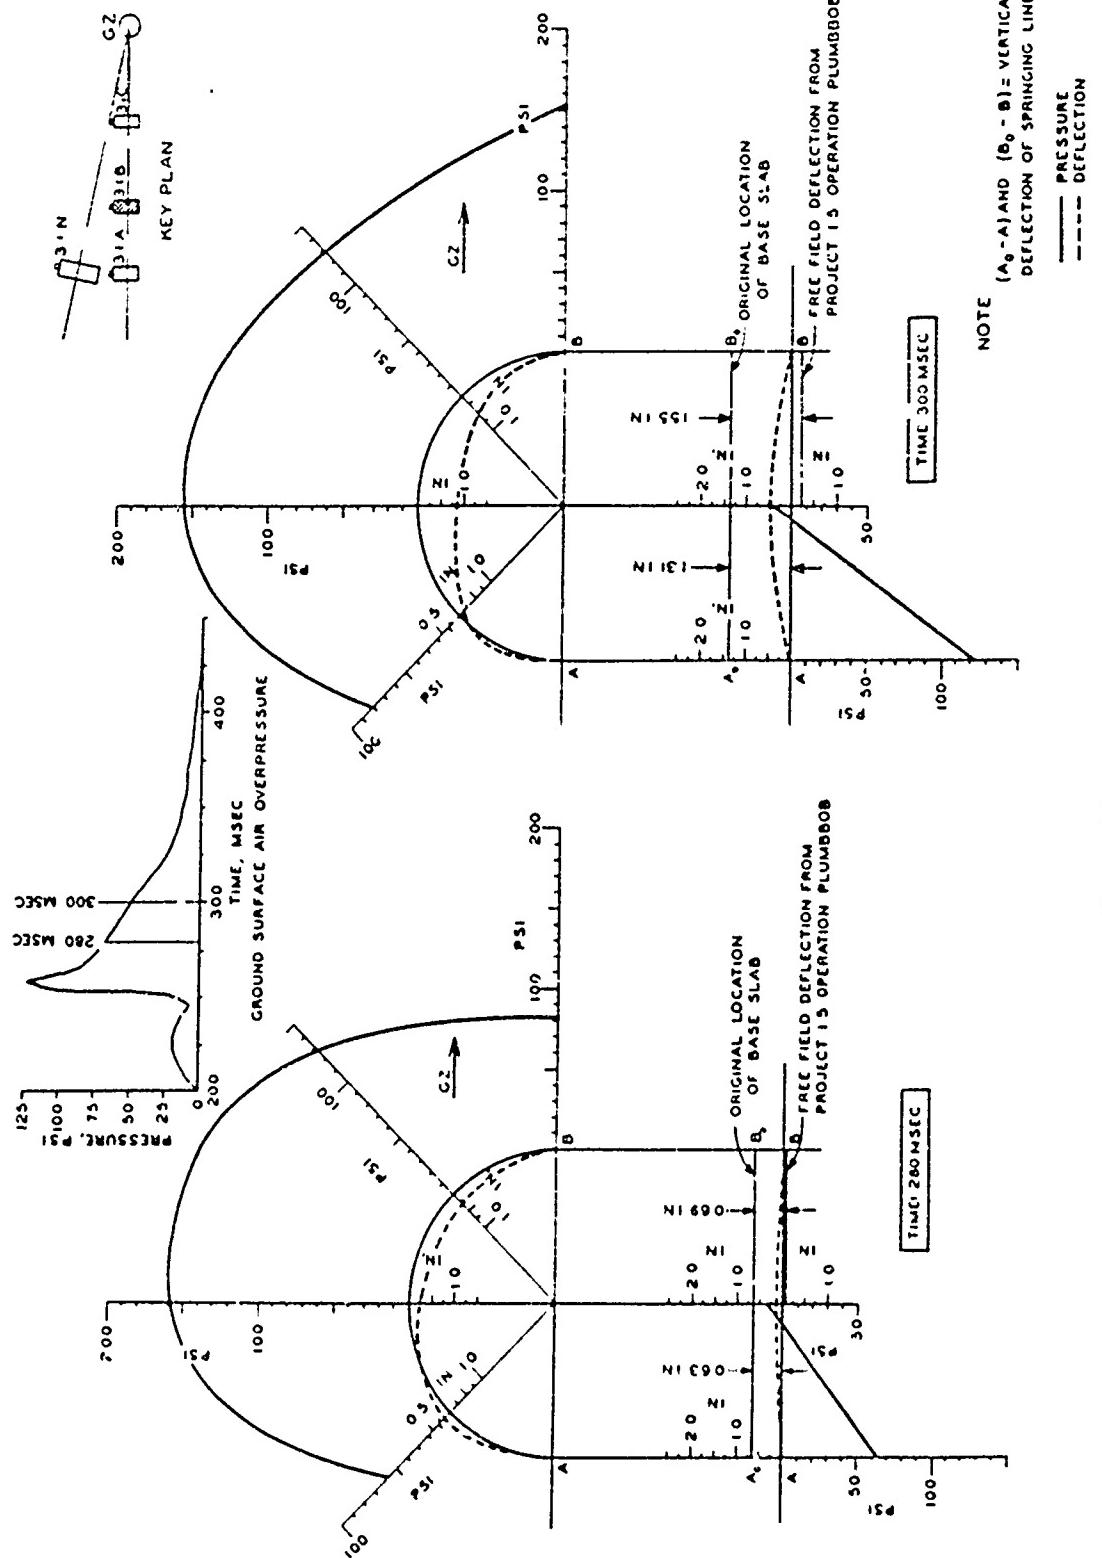
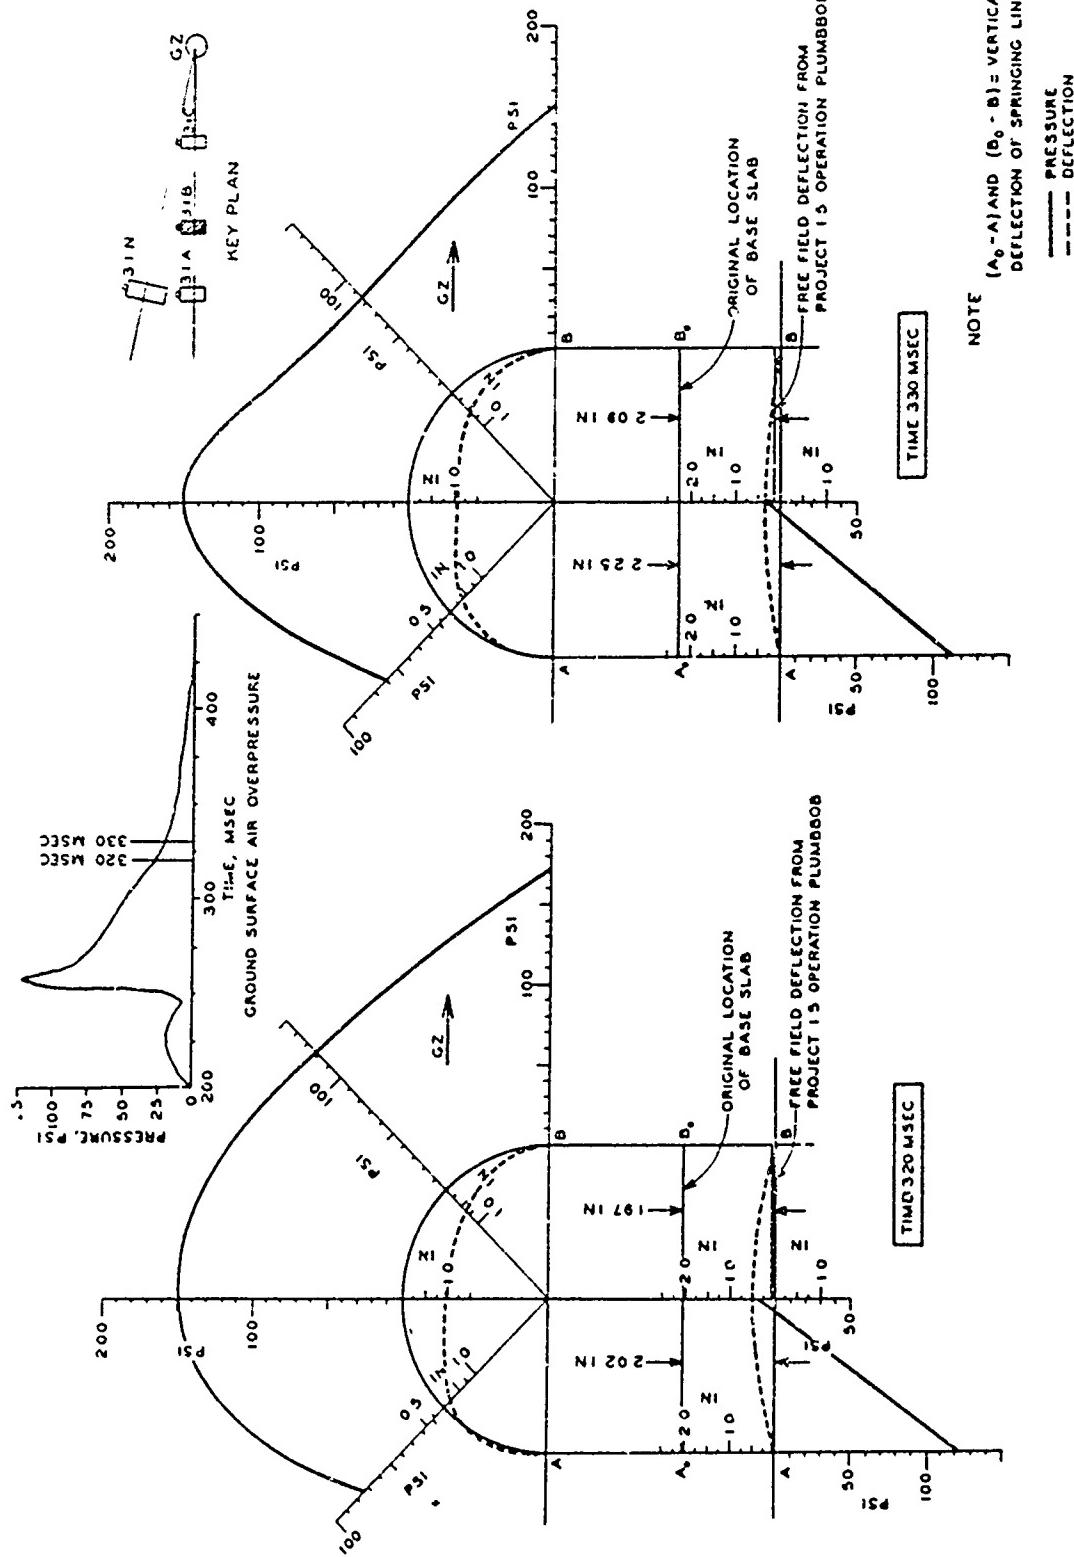
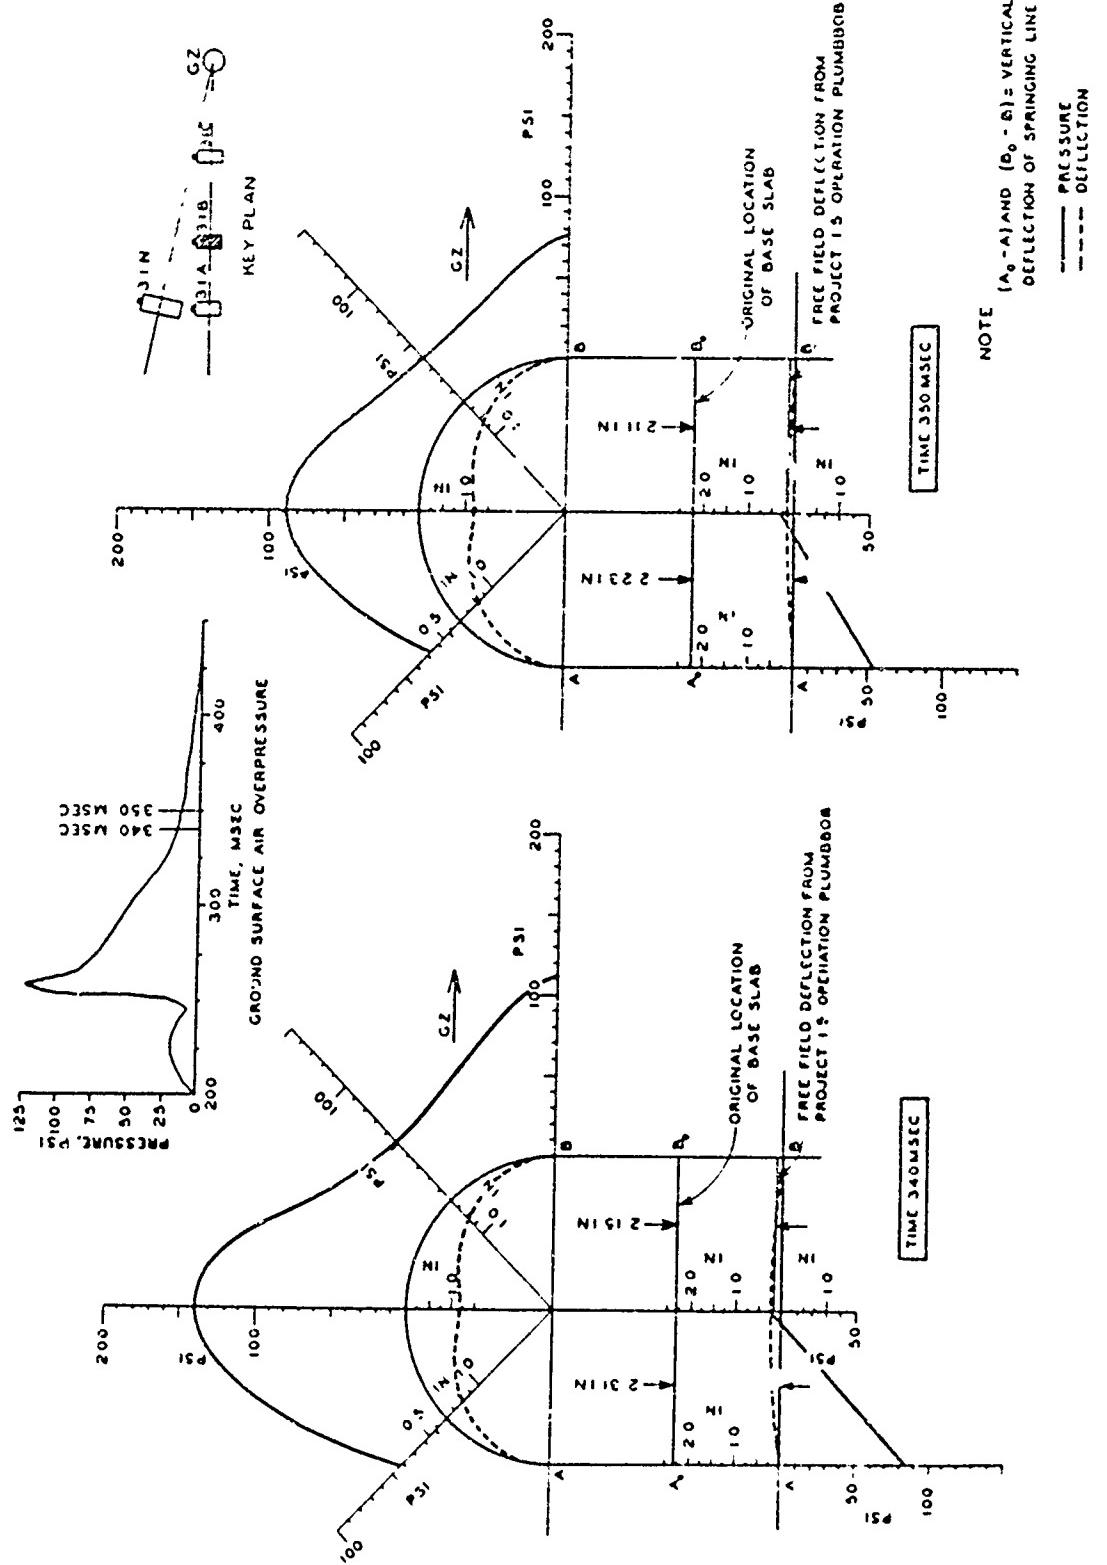
Figure 4.2 Sequential plot of earth pressure and deflection, Structure 3.1.b.

4.2.1 Transient Response to Earth Pressure. To represent graphically the transient response of the arch to the earth pressure or ground shock, sequential plots of earth pressure and deflections (Structure 3.1.b) with respect to time, along with the respective ground-surface overpressures, are shown in Figure 4.2. In the sequential plots, the base (line AB) has been removed from the arch proper, thus giving two distinct plots (i.e., arch and base slab) of earth pressure and deflection. The radial arch deflections are plotted with respect to the springing line, whereas the base slab not only shows the relative deflection of the center of the base slab

The air-induced ground shock arrived approximately 200 msec after zero time (time of detonation). The first visible effects of earth pressure on the crown of the arch occurred at 205 msec. The following is a description of the response of the arch structure at the times of the various plots shown in Figure 4.2.

At 250 msec: The precursor wave was nearly terminated and the decrease in earth pressure could be observed. In addition to the gross displacement of the structure as a whole, the arch began to deflect with respect to the springing line.

At 260 msec: The main shock arrived. Here again, the crown, by virtue of its position, was subjected to load before the free-field point, which explains why the downward movement of the base slab caught up with the downward displacement of the free-field point. Apparently the arch deflection had not yet responded to the main shock. It was also observed that the pressure at the 45-degree lines increased slightly, while the pressure at the springing line was essentially zero. This fact was also observed during the initial precursor build-up at 210 msec.

At 280 msec: The ground-surface air overpressure was approximately 70 psi and decreasing rapidly. The earth pressure continued to build up around the arch, increasing greatly at the springing line. The pressure on the slab at the center was negative, while the pressure built-up at the end was considerable, thus indicating that by now the slab had cracked through (see Figure 3.15 for crack patterns) and that the central portion of the slab was no longer capable of carrying loads transmitted by the arch. The slab under each springing line was now acting as a wall footing, carrying the load transmitted by the arch. Rather than attempt an intuitive interpretation of the pressure distribution on the base slab, the pressure distribution is shown to be triangular although the actual pressure distribution most likely was not triangular. The relative movement of the slab was greater at the center than at the ends, thus showing that the cracked slab (footings) was being punched into the soil. The arch was beginning to respond to the main shock, showing asymmetrical deflection, the haunch on the ground-zero side moved inward while the opposite haunch moved outward.

At 300 msec: The earth pressure at the springing line increased with respect to the other earth pressures around the arch ring. This might be explained as being the at-rest pressure while the other observed pressures are active pressures being reduced by arching in the soil. On the other hand, this may be due to an outward movement at the springing line and thus increase earth pressure. There are not sufficient data to determine if there was any movement at the springing line, although such movement would be consistent with the general inward deflection of the arch ring. The displacement of the free-field point became greater than the displacement of the slab.

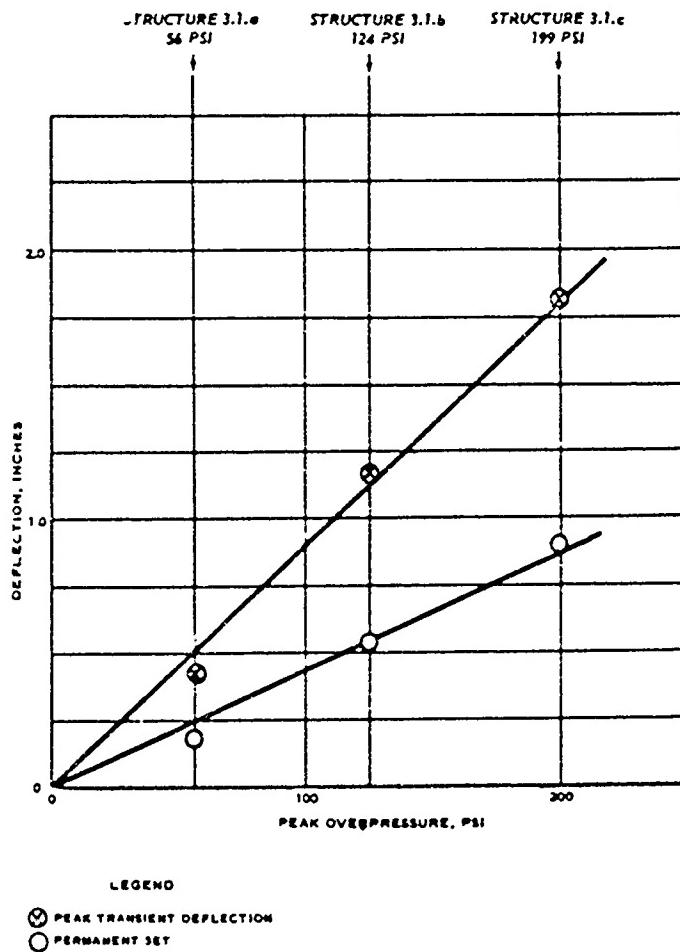
Figure 4.3 Peak transient and permanent deflections of crown with respect to springing line, Section III, Structures 3.1.a, b, and c.

The peak transient and permanent deflections of the crown with respect to the springing line are shown in Figure 4.3. The permanent deflections in this case were approximately one half the magnitude of the maximum transient deflections. These plots indicate the possibility of compiling a set of failure criteria based upon ultimate permanent set.

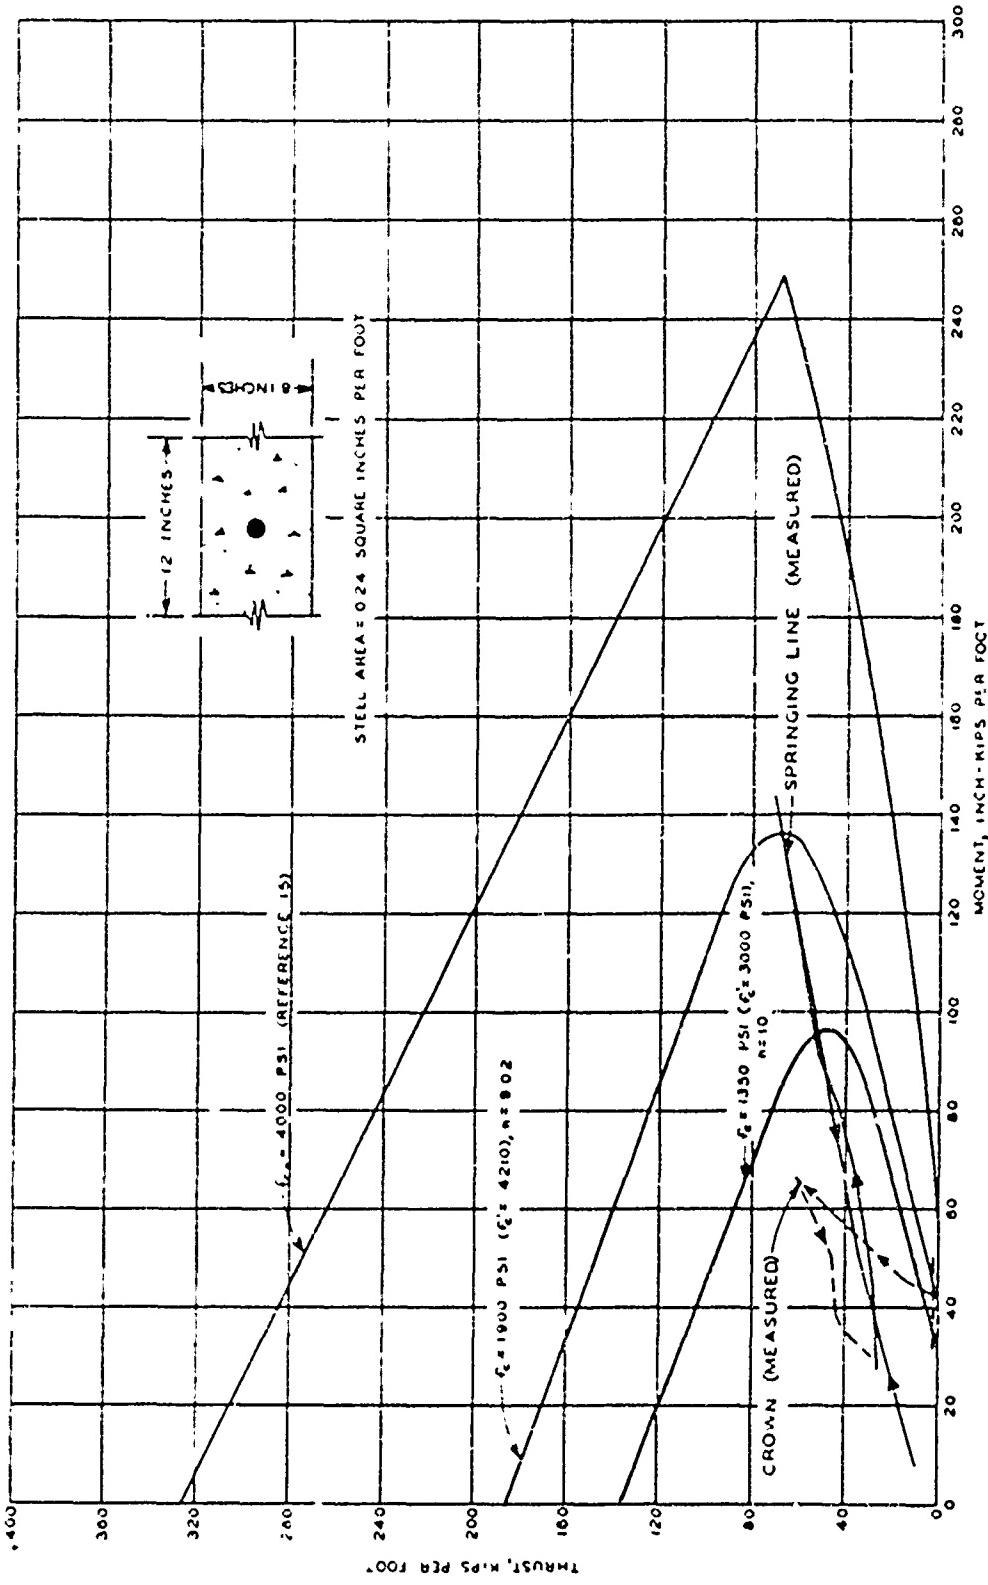
Figure 4.5 Interaction diagram for measured, design, and ultimate values of moment and thrust, Structure 3.l.n.

4.2.2 Arch Reaction. The strain information was used to determine reactions, i.e., moments, thrusts, etc., for Structure 3.1.n. A sequential plot of moment and thrust for the arch is shown in Figure 4.4. An interaction diagram of moment and thrust (using the data from Figure 4.4) for the springing line and crown is shown in Figure 4.5 along with interaction curves for the working stress of 1,850 psi for 3,000-psi concrete, the working stress of 1,900 psi for 4,210-psi concrete (actual average cylinder strength for Structure 3.1.n, Table 2.4), and the diagram for ultimate moment and thrust (Reference 15) using the dynamic strength value for 3,000-psi concrete. The diagram for ultimate moment and thrust using the dynamic value of

the measured concrete strength is not shown. The figure shows that the arch underwent appreciable bending action.
